Subject EPA-HQ-OAR-2009-0211

This is a comment in connection with EPA's E-15 fuel waiver.

I would like to share some photos of a gasoline piping sump from a site that we installed and maintain. The site has Tokheim MaxVac vapor recovery dispensers, and a CARB approved vent cap (which means the vent may hold a slight pressure in the tank). We built this site about 10 years ago. I have seen many other sites with gasoline pump sumps like this.

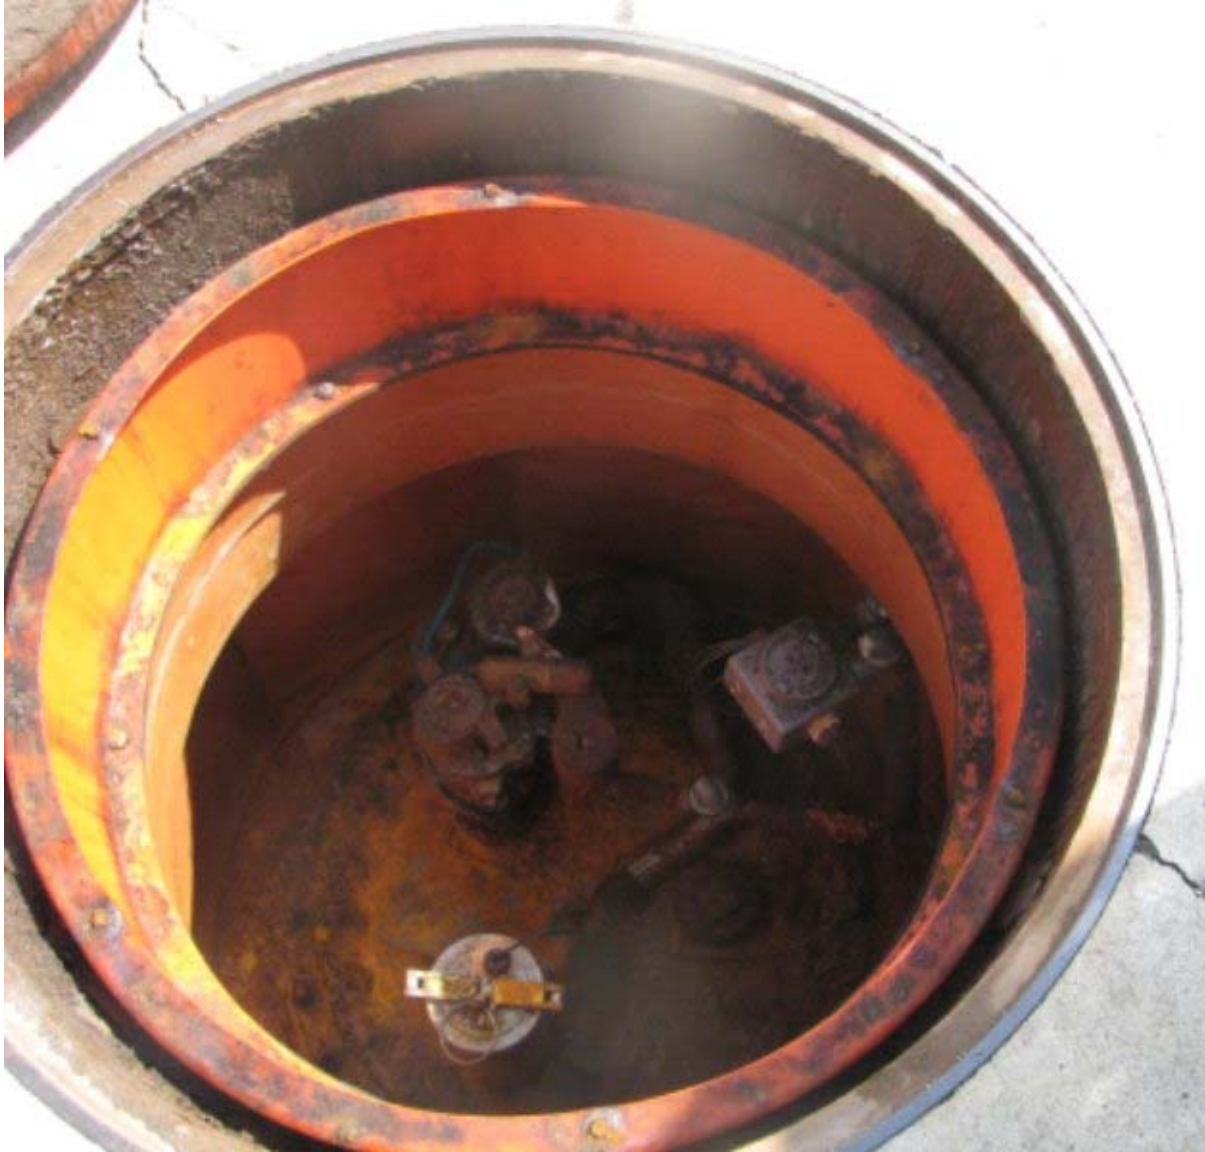
As I opened this sump there was a strong and distinct odor reminding me of battery acid. As I look in I noticed no puddles, but some condensate. All painted steel (FE Petro pump housing) is coated in corrosion, all galvanized steel (electrical conduit) covered in corrosion, all black steel (pump riser) covered in corrosion, all copper and brass (leak detector vent tube) covered in blue-green corrosion, and the VR cap has powdery white corrosion deposits. In some places the corrosion forms 'bubbles' and 'drips'. The stainless steel braid on the flexible connector does not seem to be affected. At some other locations I have noticed a dark colored liquid puddle, and at first, wondered if someone actually had dumped battery acid into the sump.

Photo 1: the whole sump. FE Petro STP at top, VR tank probe at bottom, conduit at right.

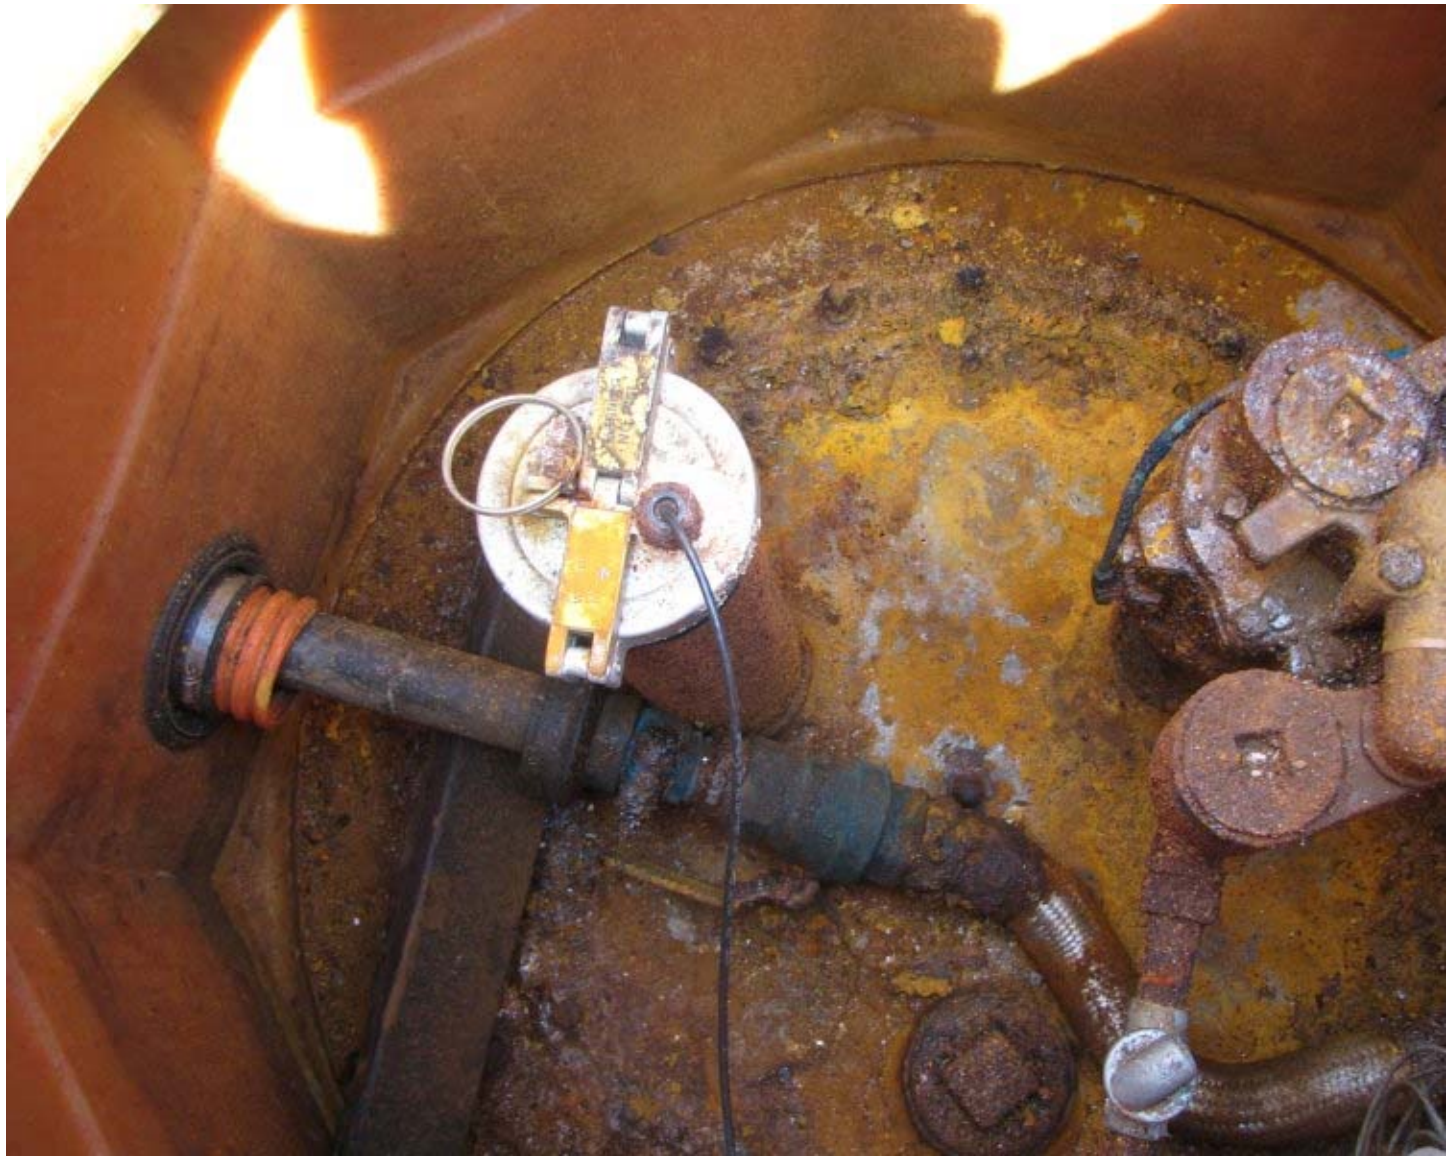
Photo 2: Corrosion on piping and galvanvanized conduit. Brass ball valve housing and piping clamp show blue. Stainless steel braid not affected, but the ends of the flex connector are corroding.

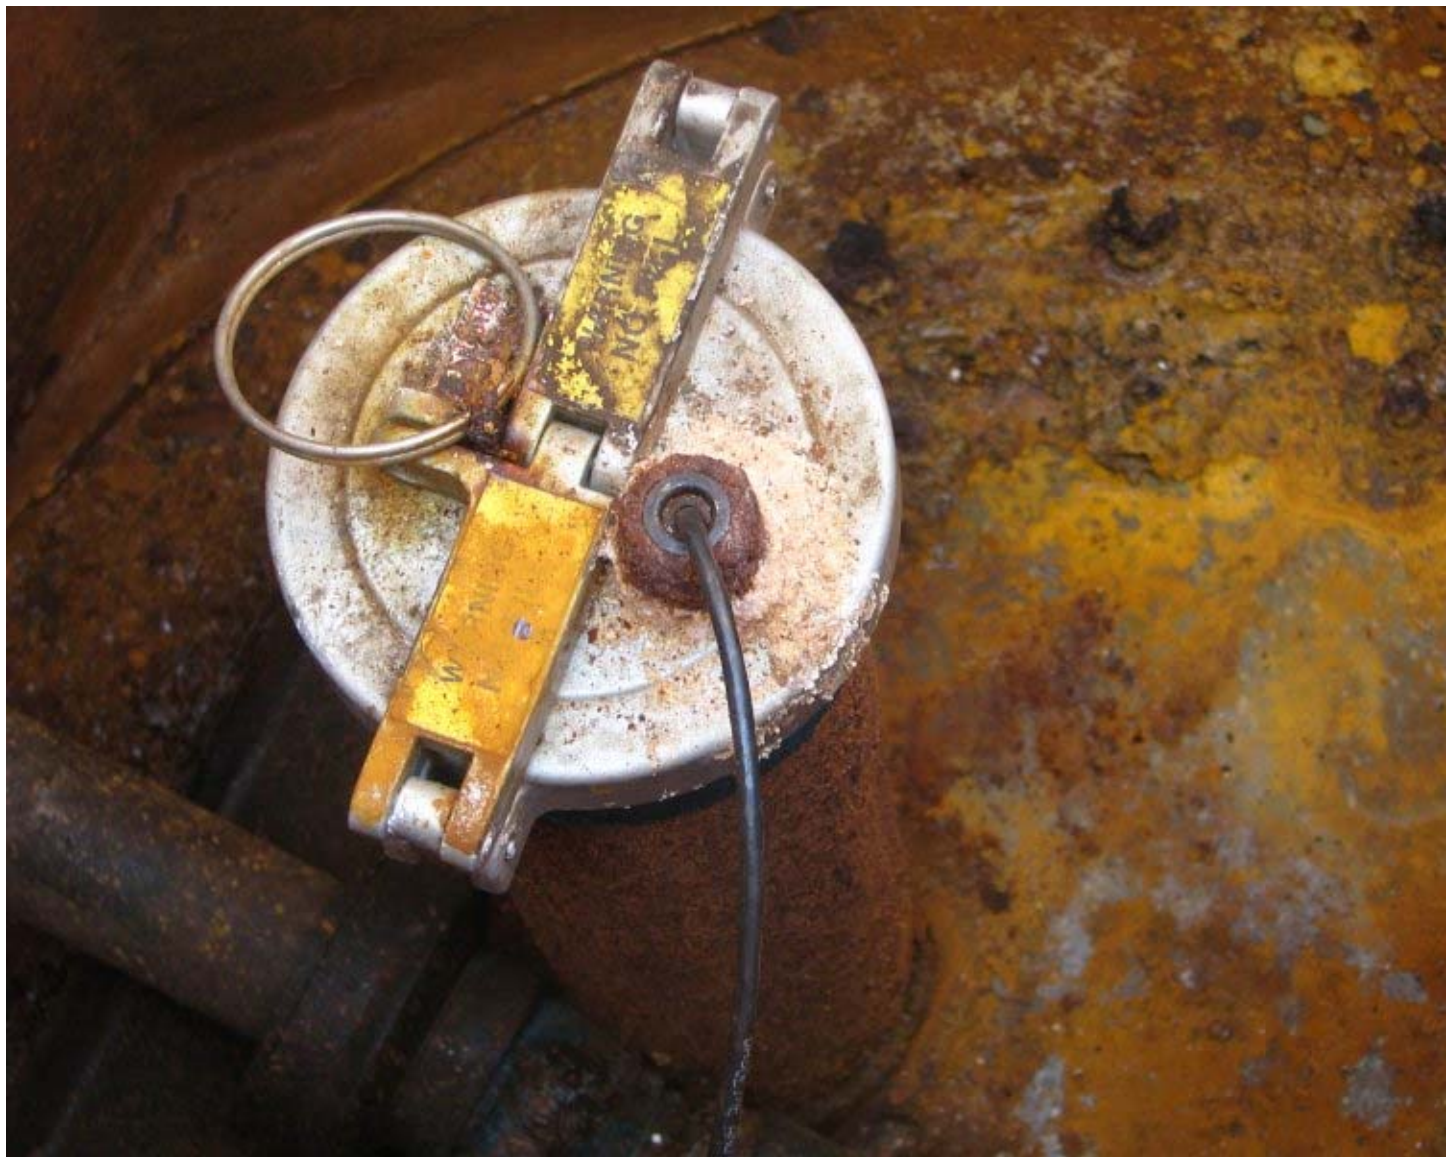
I expect that the ethanol is a more volatile component of the fuel mixture, or perhaps the vapors leak easier, and as vapors slowly leak out of the slightly pressurized tank there is, in effect, a distillation process, creating an ethanol/water condensate in the sump, having acidic and conductive characteristics. As time progresses the concentration of corrosive molecules increase in the closed sump. I am not a chemist, perhaps someone could define this better.

Photo 3: White powdery corrosion around VR probe grommet. Tank vapors may be leaking around the threads.

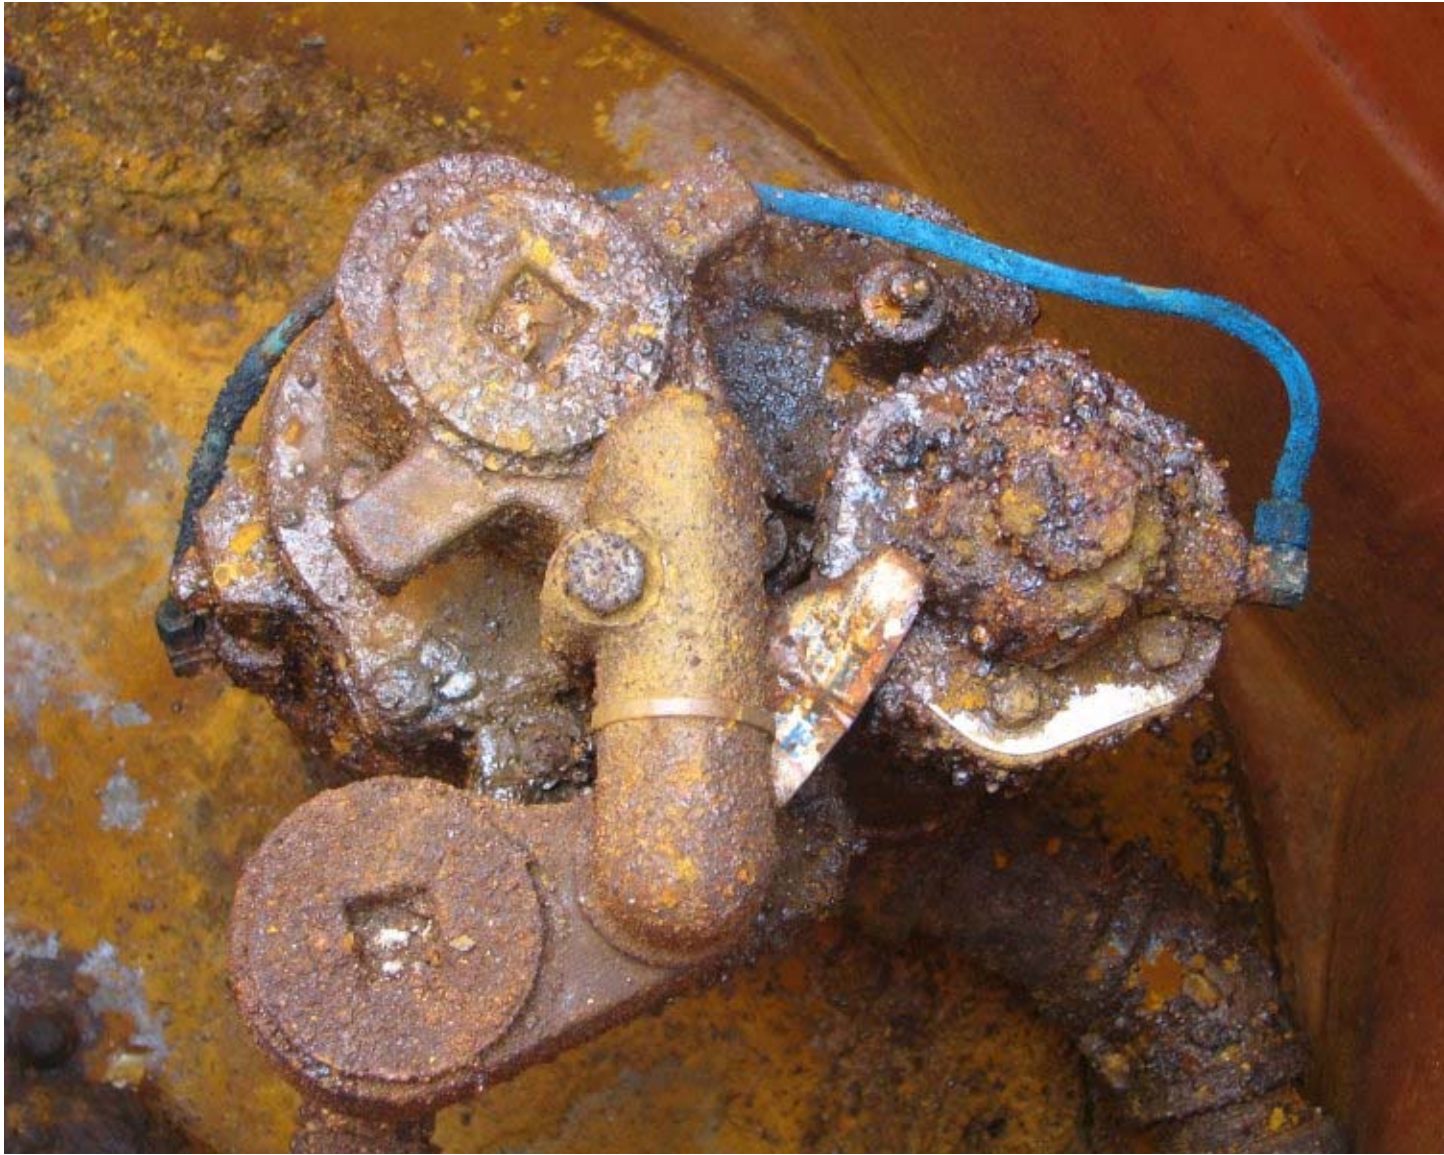
I have no idea how much longer the metal components will last before there is a leak, or how long the conduit will last before the explosion proof qualities are compromised. I have no real answer for the customer in terms of supplying better equipment. I do know that due to severe corrosion I was unable to loosen the electrical yoke bolt on the pump housing to safely change the leak detector. The head of the bolt has already lost its shape.

Photo 4: Bubbles of corrosion on STP. Notice the brilliant blue-green copper tube. The yolk bolt is at the center. It didn't look very bad until the wrench touched it, and the corrosion flaked off, leaving an undersized head with rounded corners. Some corrosion was wiped off the leak detector label to read the serial number. Corrosion seems worse where the cooler fuel flows through the housing. On bottom surfaces corrosion drips over 1 inch long are present. Tank manway bolts and nuts are covered in corrosion.

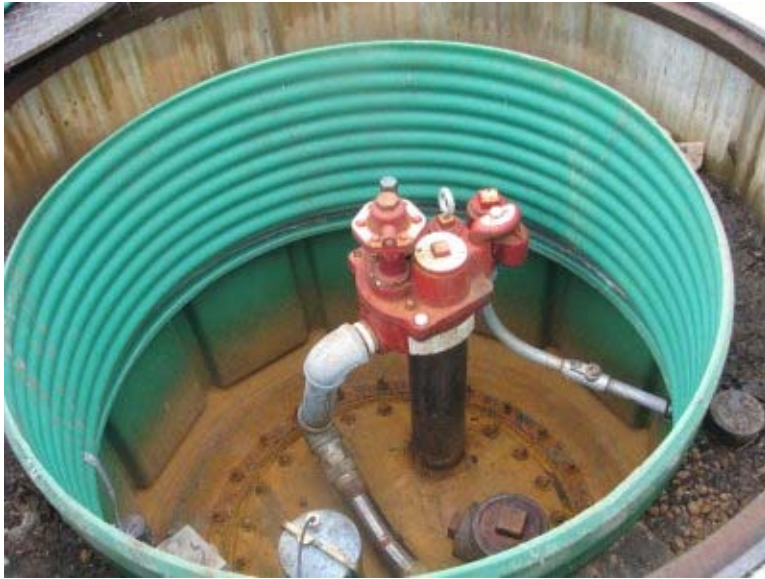
Photo 5: What we should expect. This sump is about 4 years older, and is on a diesel tank at a nearby site.
